The Hopkins Ultraviolet Telescope

Engineering Report
for the
Astro-2 Mission

September 1995

The Johns Hopkins University
Center for Astrophysical Sciences

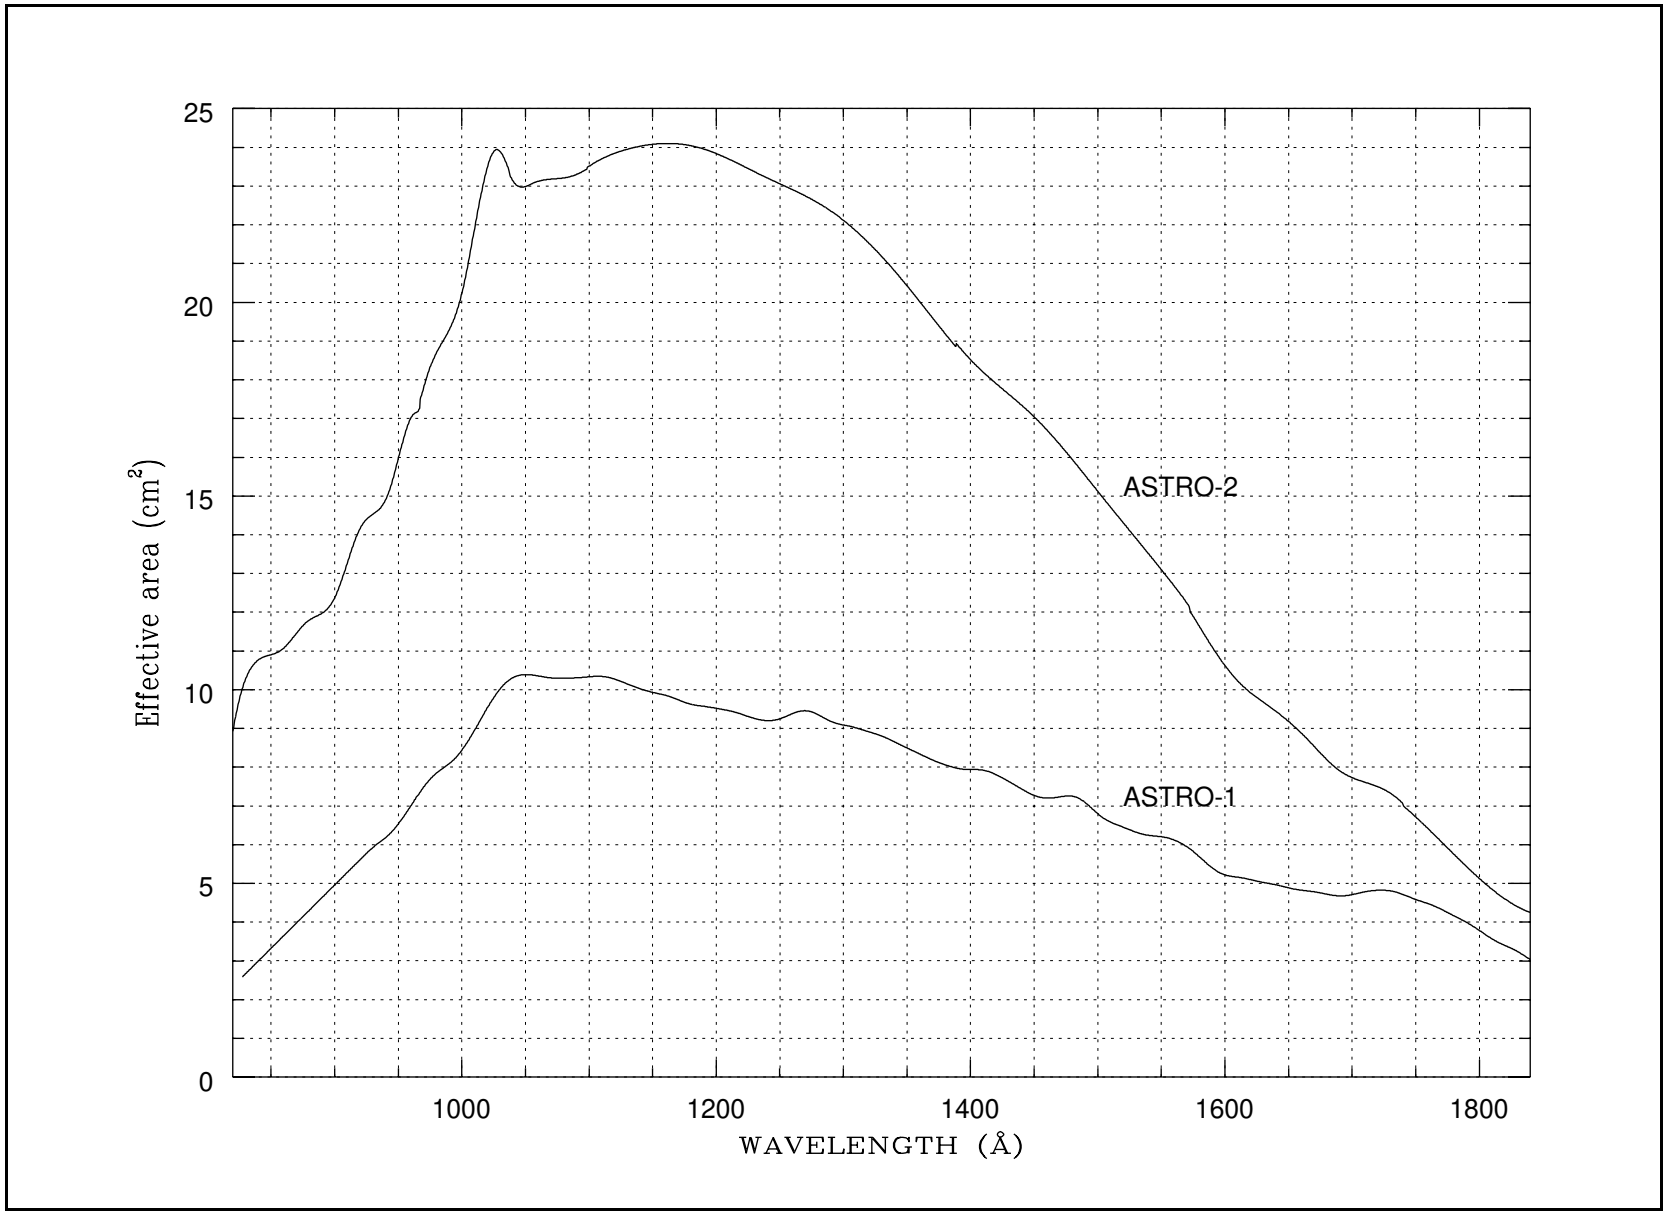
Figure 3-1

The net effect of the new coatings on the grating and primary mirror can be seen in figure 3-1 at the end of this section. The effective area was increased by more than a factor of two for all wavelengths shorter than 1600 Å.

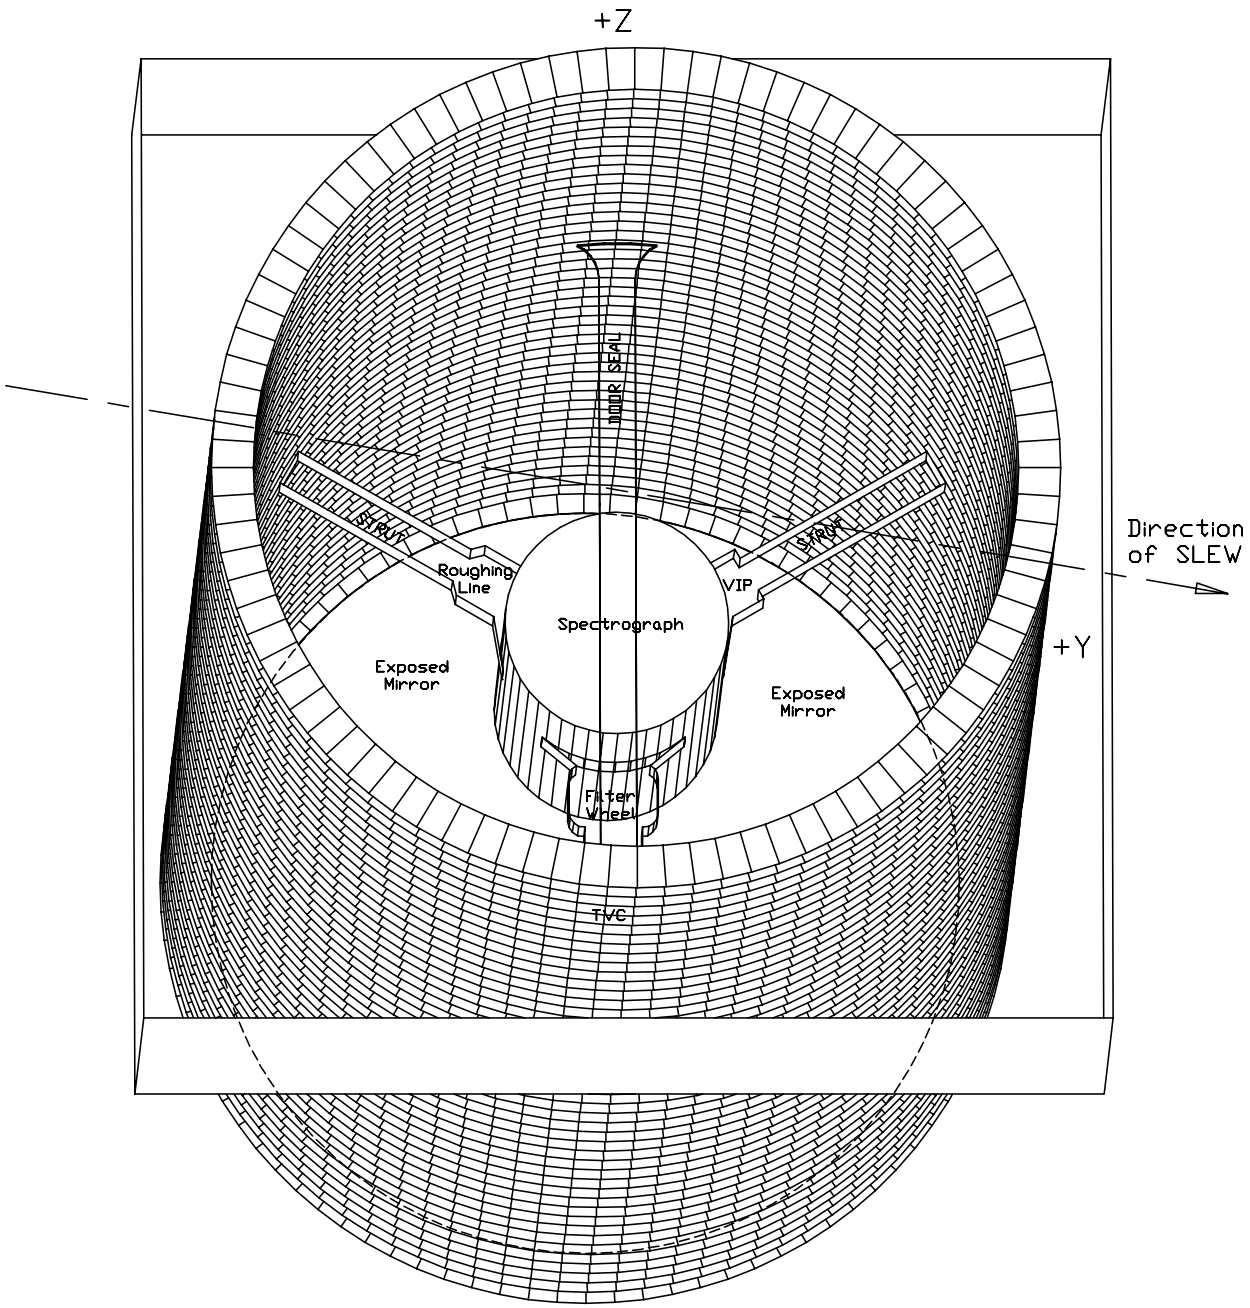
Figure 5-1

At MET 6/11:15, the 20º minimum ram constraint of HUT was violated during a setup. The doors were mistakenly opened seven minutes early and were fully open at a ram angle of 8.6º. This angle increased linearly with time until a safe angle of 22º was reached five minutes later. Approximately 40% of the +Z portion of the mirror was exposed during the violation, with a peak value of 16% as shown in figure 5-1.

This constraint violation occurred due to an error in the sequence load. The doors were closed prior to the QUIT on the previous target as required. The sequence load for the next target, (M49), should have included a closed door state but had a door state of '5' (both open) instead. This

The ram constraint is derived from the 16º angle (plus margin), before the edge of the HUT primary mirror is exposed. Silicon carbide is degraded by direct exposure to atomic oxygen. Analysis up to this point does not indicate any noticeable degradation. The plot on the following page shows the point of maximum mirror exposure and the direction of SLEW. This indicates that approximately the top 40% of the mirror was directly exposed to the ram during the SLEW. The total duration of the exposure lasted six minutes, although the maximum exposure to any part of the mirror did not exceed two minutes.

Since the direction of SLEW only exposed the +Z portion of the mirror, it would be difficult to determine if a small degradation of the silicon carbide coating took place. Only a full aperturecalibration before and after the incident would be able to show the degradation. There has been no noticeable drop in efficiency noted to this point.

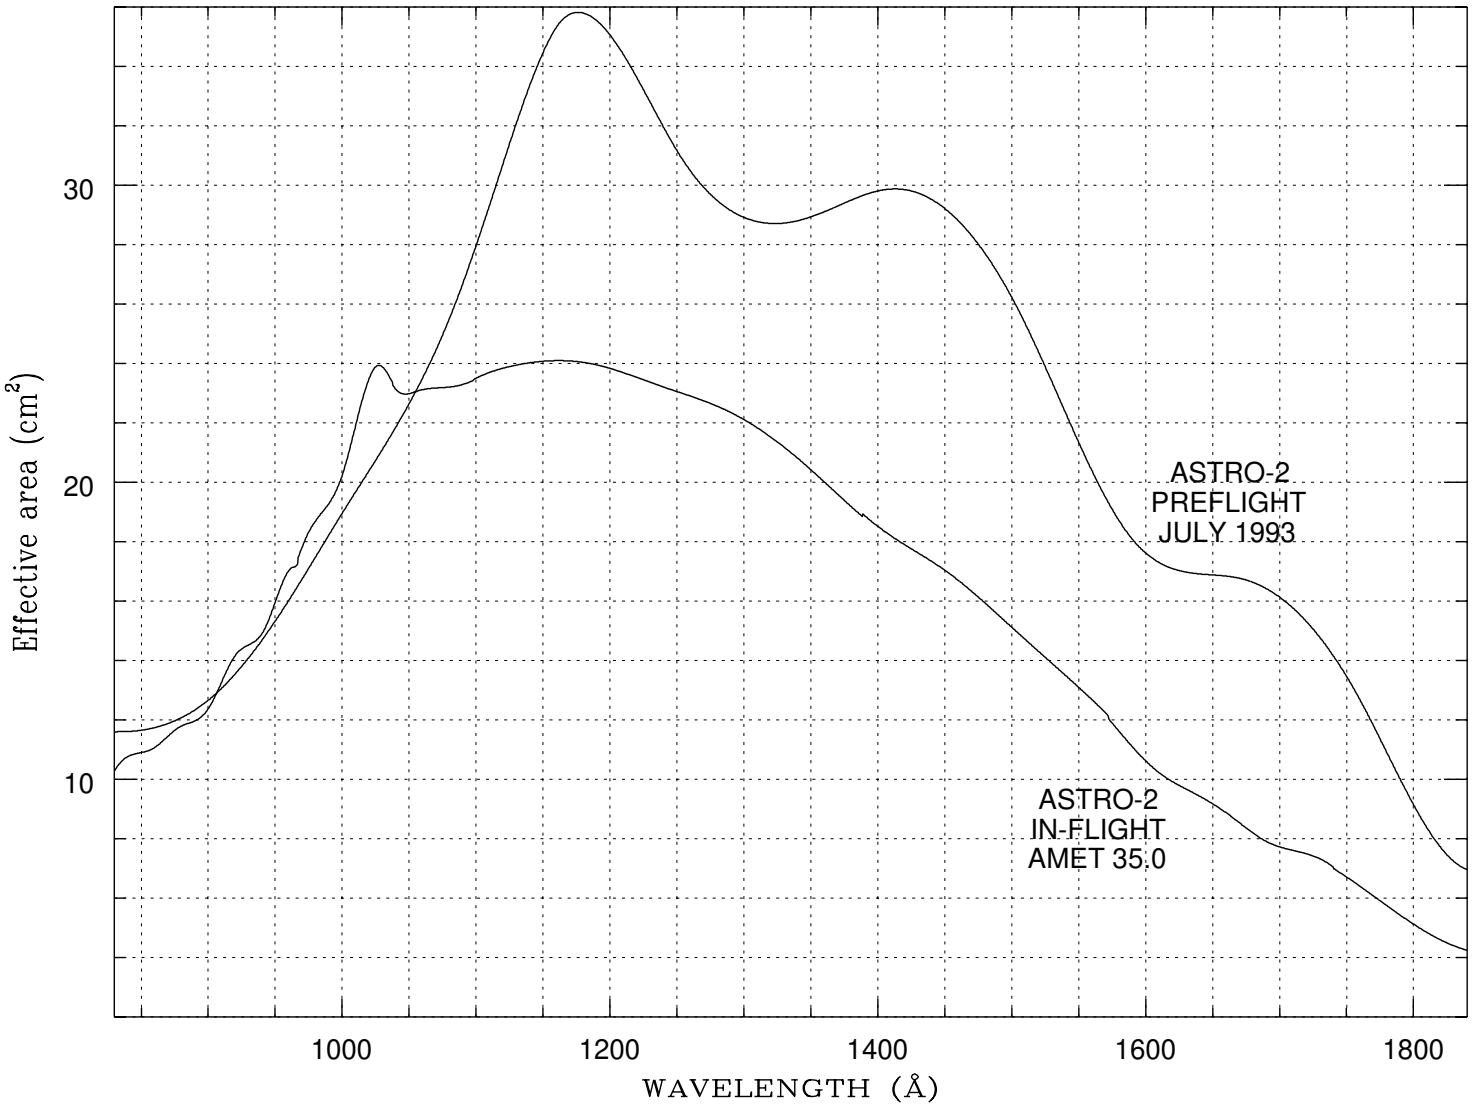
Figure 7-1

The ground calibration of the instrument's sensitivity differed as much as 45% from the calibration obtained in flight. This is shown in figure 7-1, and discussed in detail in §7.2. A decline of at least 30% was expected due to the aging of the detector's photocathode.

The discrepancy between the initial in-flight calibration and the predicted efficiency was small. From the short wavelength end of the detector to 1055 Å, the effective area was greater than the preflight calibration, up to a peak difference of 14% at 1028 Å. Above 1055 Å however, the effective area was smaller than the initial calibration with peak differences as follows: 33% lower at 1176 Å, 39% lower at 1413 Å, and 50% at 1700 Å. A plot of the preflight calibration versus the in-flight calibration is shown in figure 7-1. Since roughly a 30% decline in efficiency was expected (from degradation of the detector's photocathode over time), the in-flight calibration was very close to the predicted values.

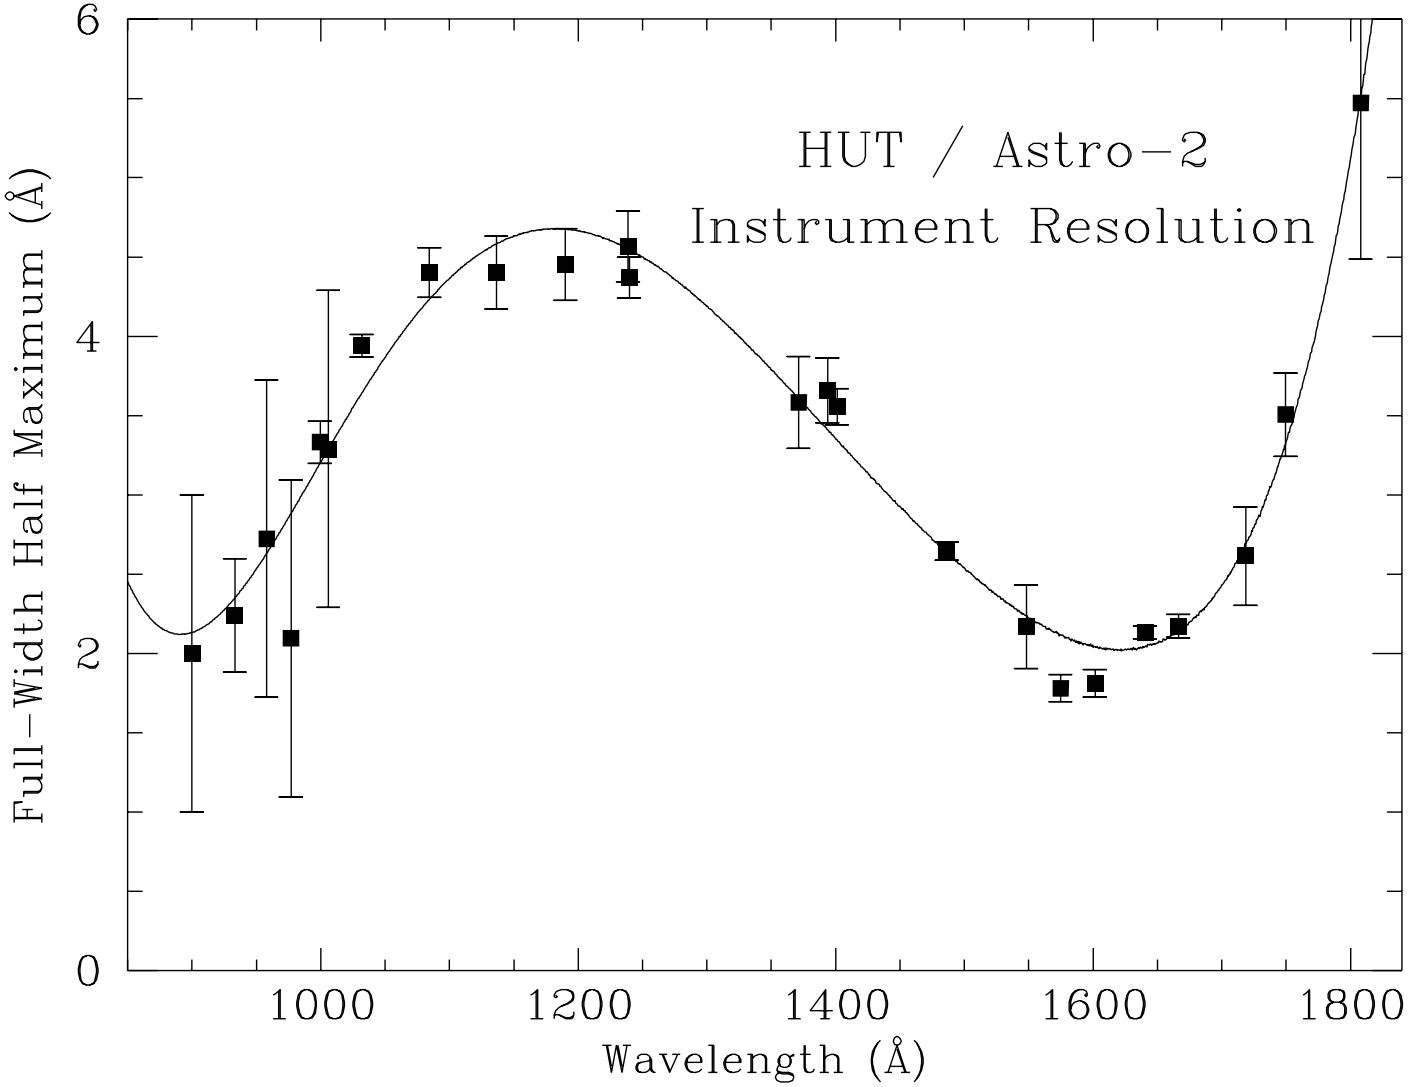
Figure 7-2

Due to alignment differences between the spectrograph and television camera, it was not possible to focus both simultaneously. Ideally, the best spectrograph focus position would be used during the flight but the 380 μm difference in focus between the two was large enough to force the use of a compromise mirror position about 100 μm from the optimum spectrograph focus. The worst focus was at 1250 Å, where the spectral resolution was limited to 4.5 Å. The points of best focus were at 900 Å and 1600 Å, where the resolution was 2 Å. These positions are shifted slightly from the desired locations of 1050 Å and 1350 Å. This shift can probably be attributed to the compromise mirror position used. A plot of the spectral resolution versus wavelength appears in figure 7-2.
